| <b>Prüfbericht-Nr.:</b><br><i>Test report no.:</i> | <b>DE25I4ZS 001</b> | <b>Auftrags-Nr.:</b><br><i>Order no.:</i> | 30010 2513 | Seite 1 von 17<br>Page 1 of 17 |
| <b>Prüfgegenstand:</b><br><i>Test item:</i> | Surface coating (for caravan) | | | |
| <b>Bezeichnung / Typ-Nr.:</b><br><i>Identification / Type no.:</i> | HailGuard Pro R on Glass-fiber laminate [GFK] | | | |
| <b>Auftrags-Inhalt:</b><br><i>Order content:</i> | Hail Impact Test | | | |

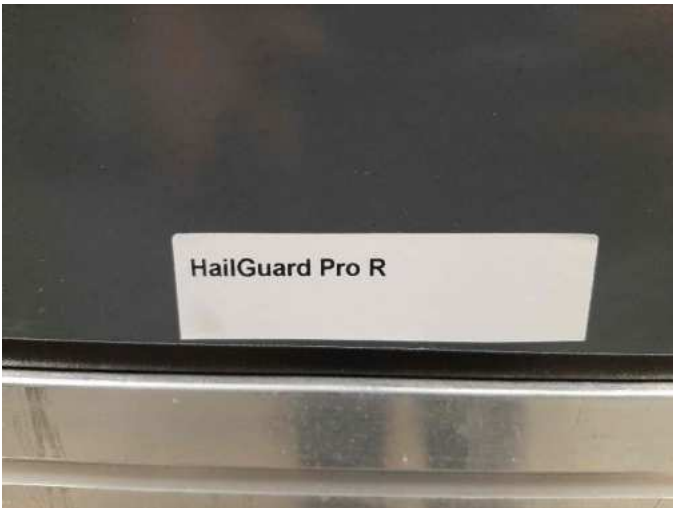
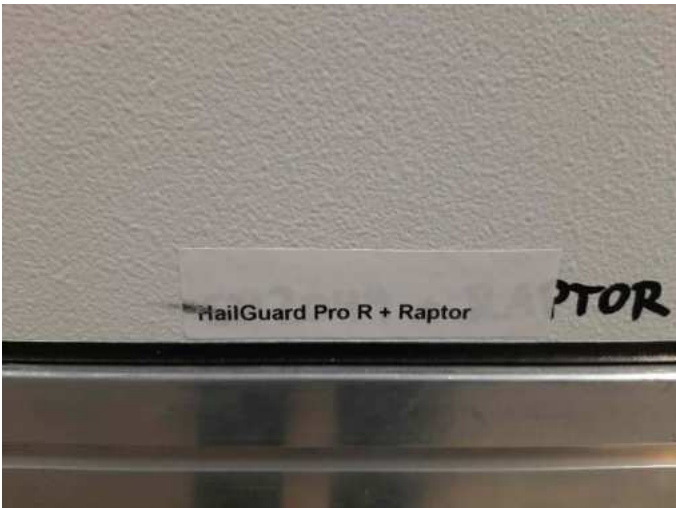
| Initial inspection – Marking - GFK | | Final inspection – marking – GFK-TC | |

| HV2025000041 | Several pre-marked surface damages | | |

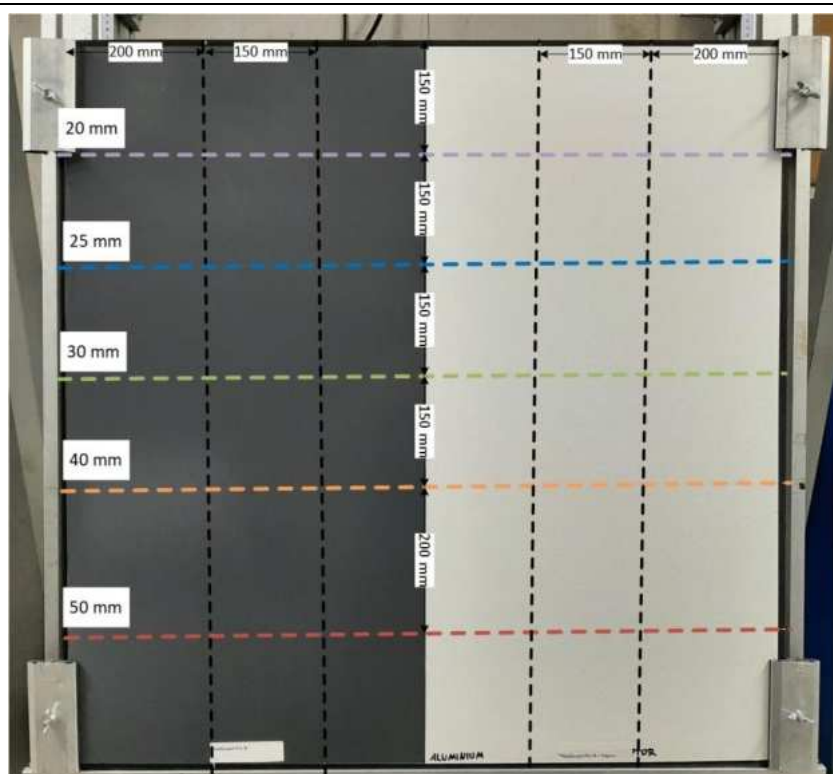
Description of impact location

Supplementary information: Cross-points of lines are impact locations with remarked ice diameter

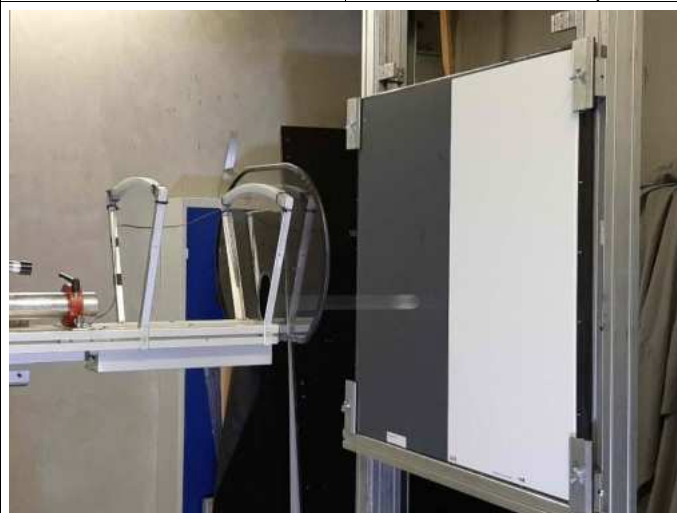
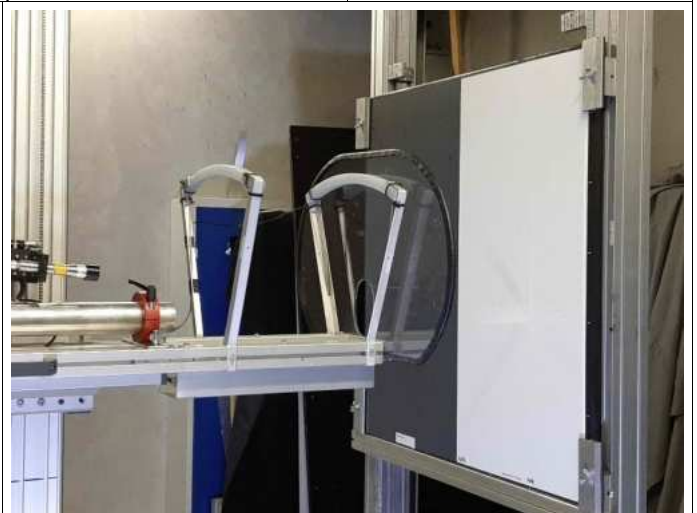
| GFK | Example of impact – 40 mm | GFK-TC |

| | Visual problems (distance; 5 m) | HW 4 <b>passed</b> ; <u>with 40 mm</u><br>NO cracks visible<br><b>NO dents visible</b><br>HW 5 <b>failed</b> ; <u>with 50 mm</u> | HW 4 <b>passed</b> ; <u>with 40 mm</u><br>NO cracks visible<br><b>NO dents visible</b><br>HW 5 <b>failed</b> ; <u>with 50 mm</u> | N/A* |
| | Visual problems (near; < 0.5 m) | HW 2 <b>passed</b> ; <u>with 20 mm</u><br>NO cracks visible (under use of magnifier)<br>Dents partial visible depending on light and point of view | HW 4 <b>passed</b> ; <u>with 40 mm</u><br>NO cracks visible (under use of magnifier)<br>Dents partial visible depending on light and point of view | N/A* |

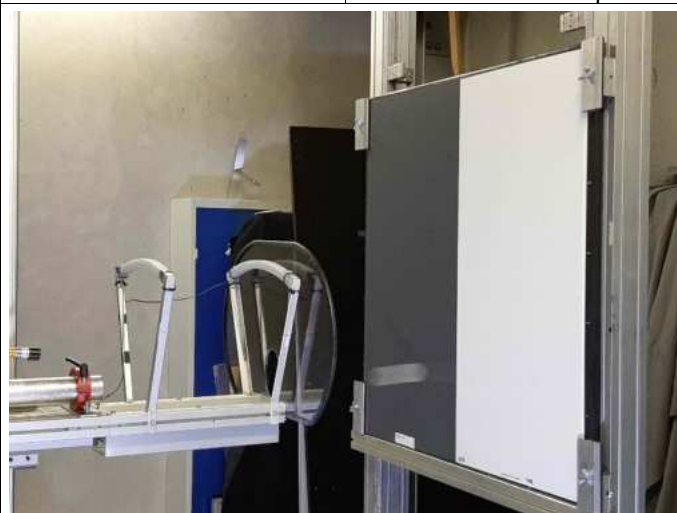
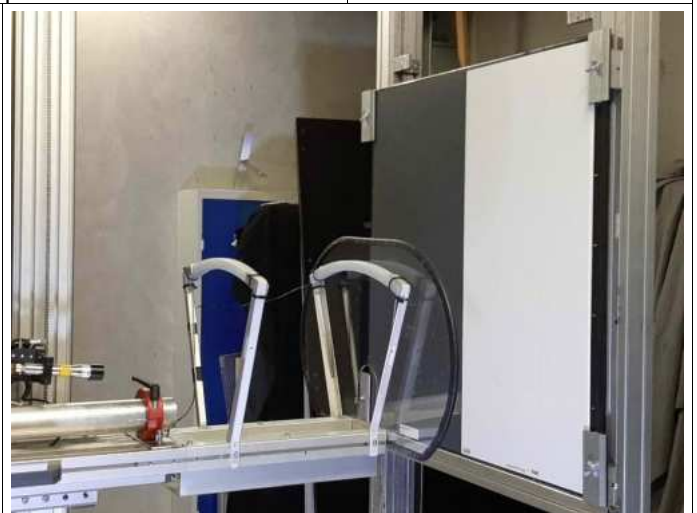
| GFK | Example of impact – 50 mm | GFK-TC |

| | Additional technical remark | <b>Generally water tight ;</b><br>Even if GFK-layer is broken, base coating is still water tight (up to <u>50 mm/HW5</u> ) | <b>Generally water tight ;</b><br>Even if GFK-layer is broken, complete coating is still water tight (up to <u>50 mm/HW5</u> ) | — |

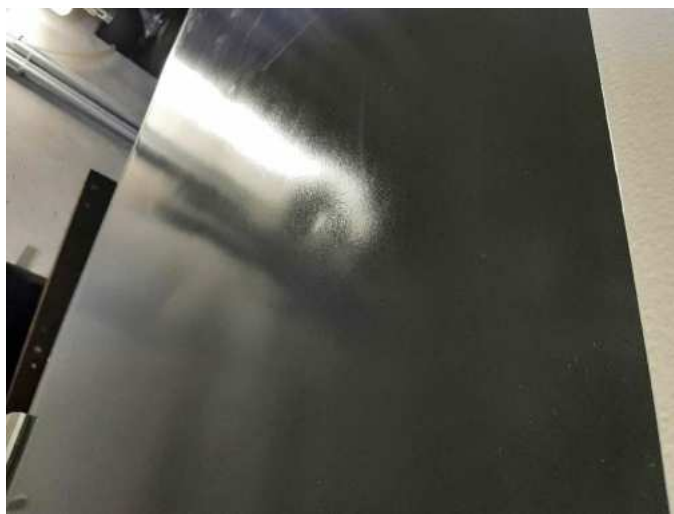
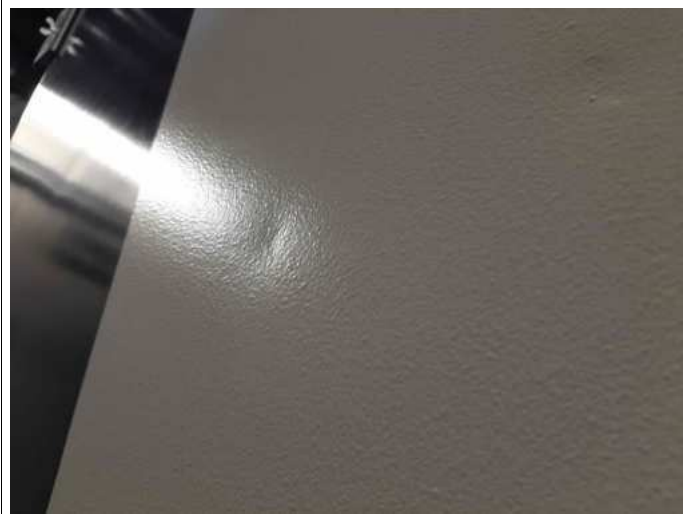
Damage of impact – 50 mm

\*GFK-layer is broken, but coating is still intact and water tight; also at HW5/50 mm

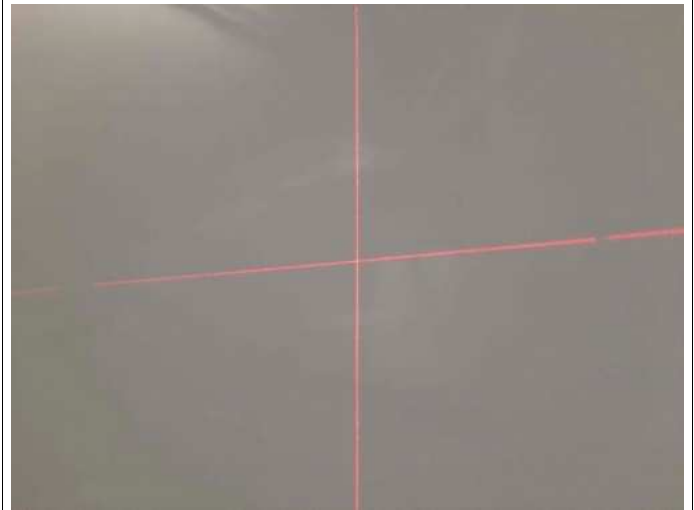
Comparable Damage of impact – 30 mm

Comparable impacts on un-coated GFK surface.
